Whispering Springs

Level 2 Reserve Study

Report Period – 01/01/2017 – 12/31/2017

Type of Study	Update w/Site Visit
Date of Property Inspection	6/14/2016
Prepared By	Dale Gifford
Analysis Method	Cash Flow
Funding Goal	Full Funding

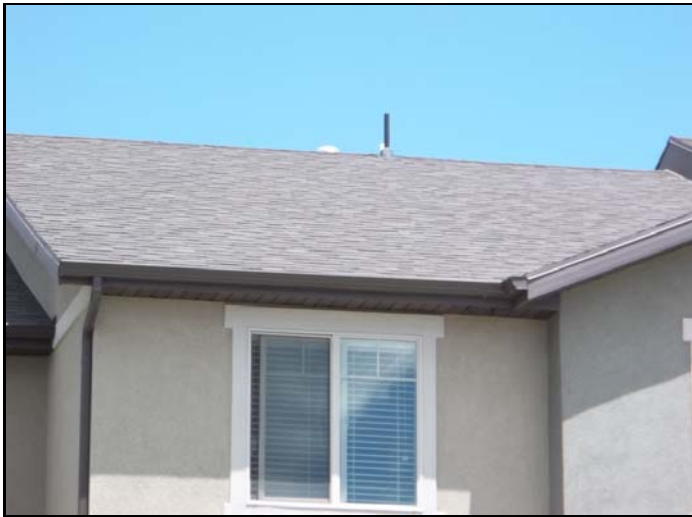
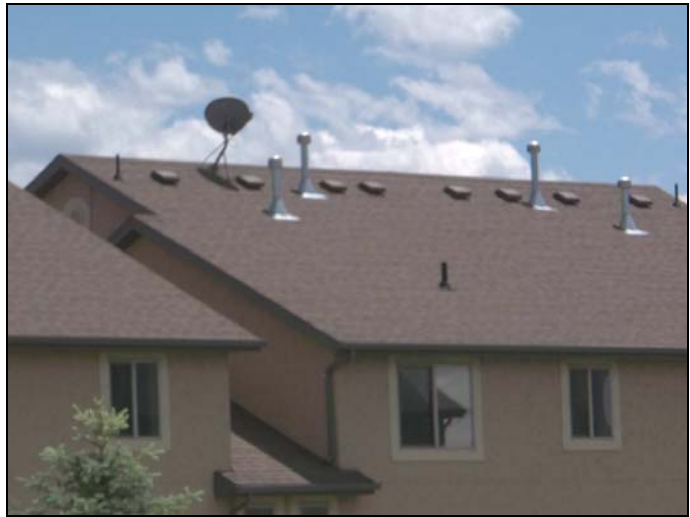
Comp #: 105 Pitched Roof - Comp Shingle - Replace

The roofs are in good condition. We recommend funding to replace this component approximately every 20 - 25 years. Remaining life based on current age.

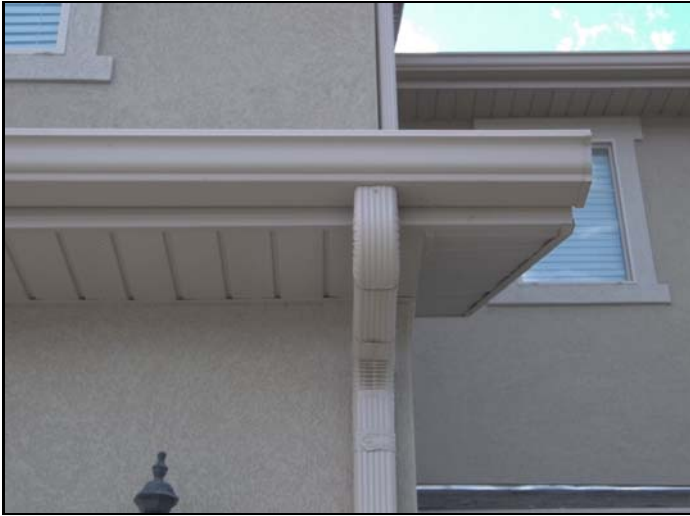
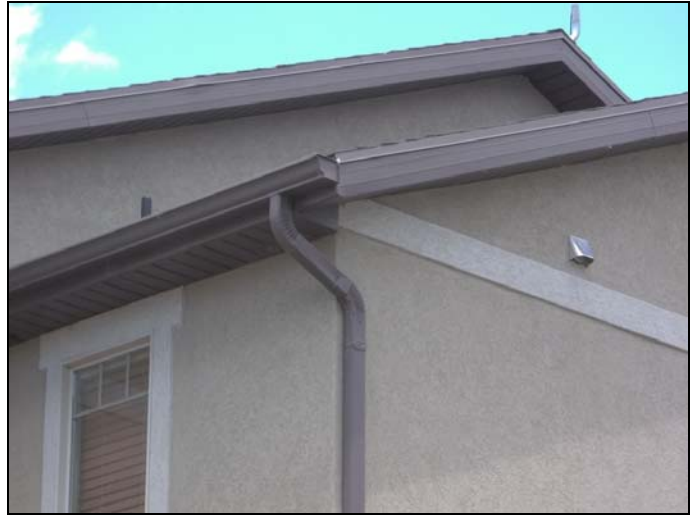
Comp #: 120 Rain Gutters/Downspouts - Replace

The rain gutters and downspouts are in good condition. We recommend replacing the rain gutters and downspouts at the same time as the roof replacement (see Comp# 105 Pitched Roof - Comp Shingle - Replace) to ensure proper function and to take advantage of the cost savings benefits. We recommend funding to replace this component approximately every 25 years. Remaining life based on current age.

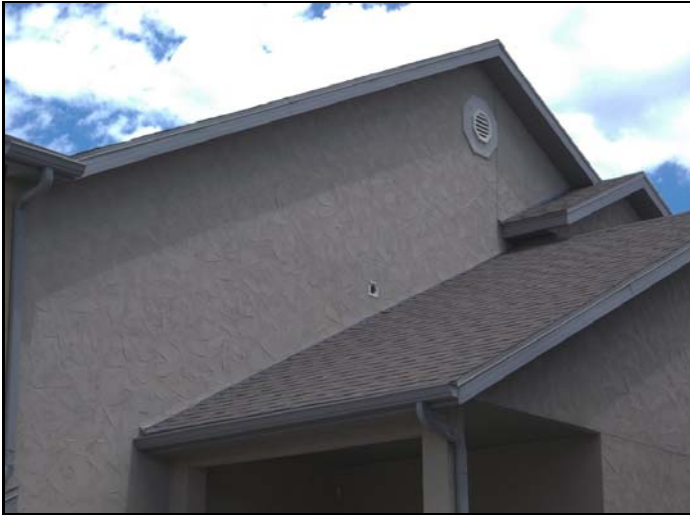
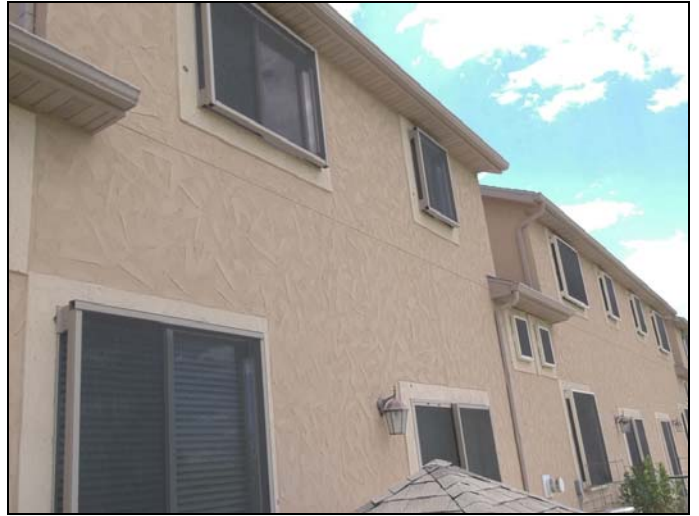
Comp #: 201 Stucco Surfaces - Repaint

The stucco surfaces are generally in good condition. Golf ball damage was noted at the time of the inspection. We recommend funding to repair/repaint this component approximately every 12 - 15 years to protect the stucco surface and maintain appearance. Remaining life based on current age.

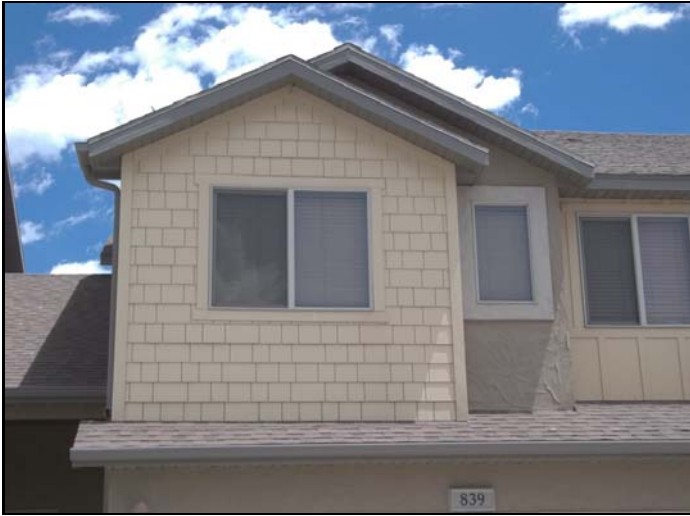
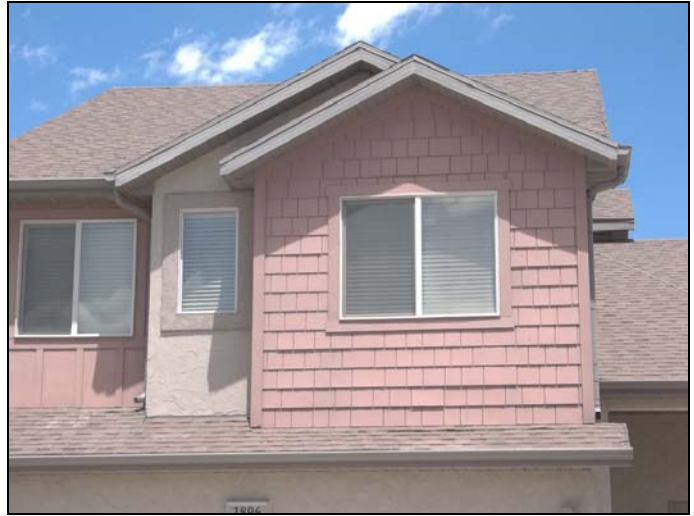
Comp #: 215 Siding - Repair/Repaint

The siding painted surfaces are in fair to poor condition. Fading and water damage were noted at the time of the inspection. We recommend funding to repair/repaint this component approximately every 6 - 8 years to maintain appearance and to protect the siding surfaces. Remaining life is based on current age.

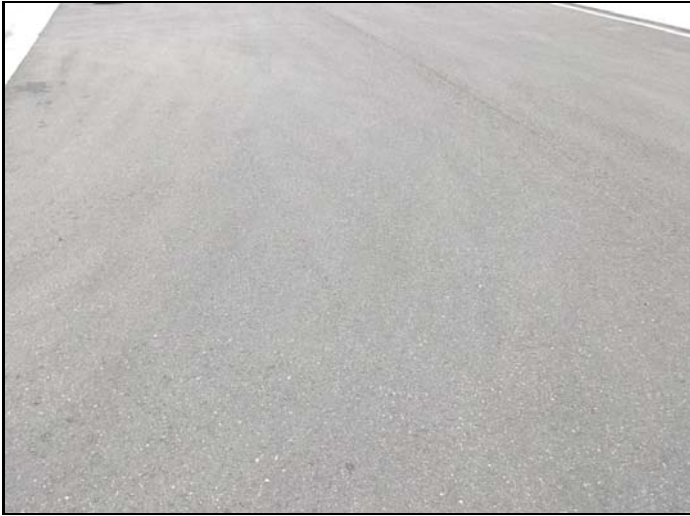
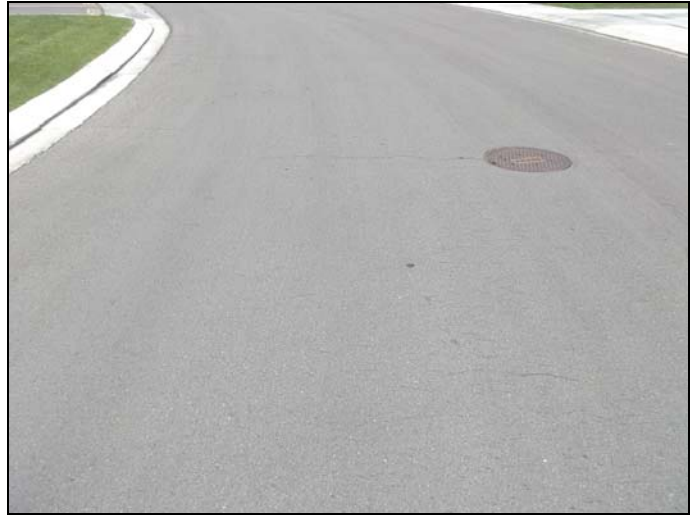
Comp #: 401 Asphalt - Overlay

The asphalt surfaces are in good condition. Cracking and raveling were noted at the time of the inspection. We recommend funding to overlay this component approximately every 20 - 25 years. Maintain seal coat schedule to ensure full useful life (see Comp# 402 Asphalt - Seal Coat). Remaining life based on current age.

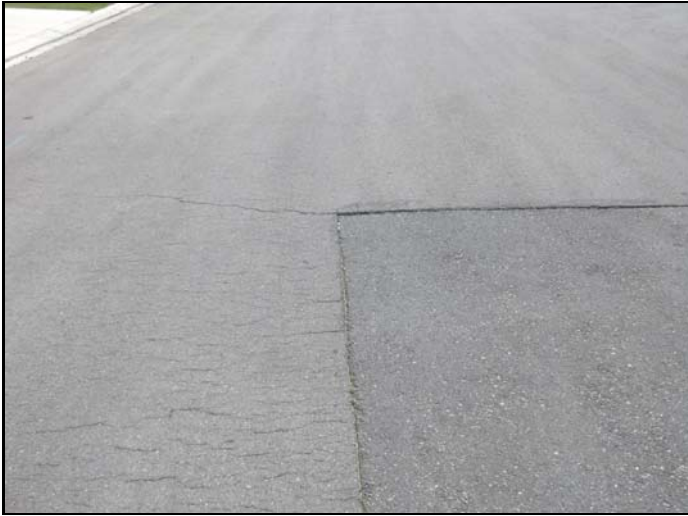
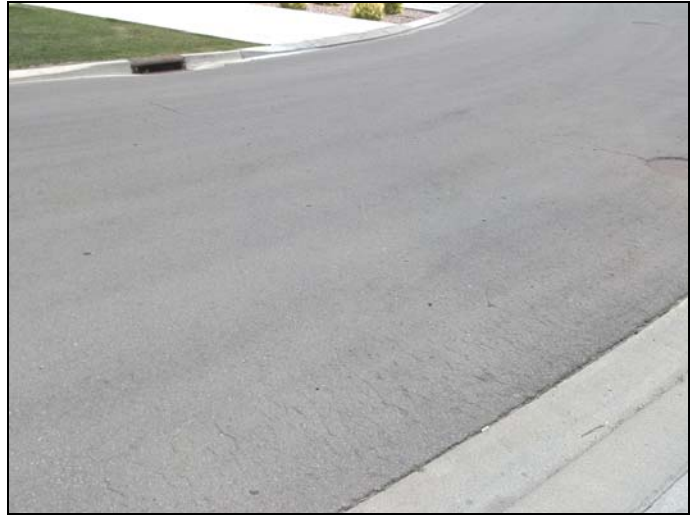
Comp #: 402 Asphalt - Seal Coat

The asphalt seal coat is in poor condition. Cracking and raveling were noted at the time of the inspection. Seal asphalt surfaces regularly to prevent premature overlay (see Comp# 401 Asphalt - Overlay). We recommend funding to seal this component approximately every 3 - 5 years. Remaining life based on current condition.

The project programmed to occur this fiscal year (FY2017) is asphalt seal coat (Comp# 402). We have programmed an estimated \$10,062 in reserve expenditures toward the completion of this project. (See page 15)

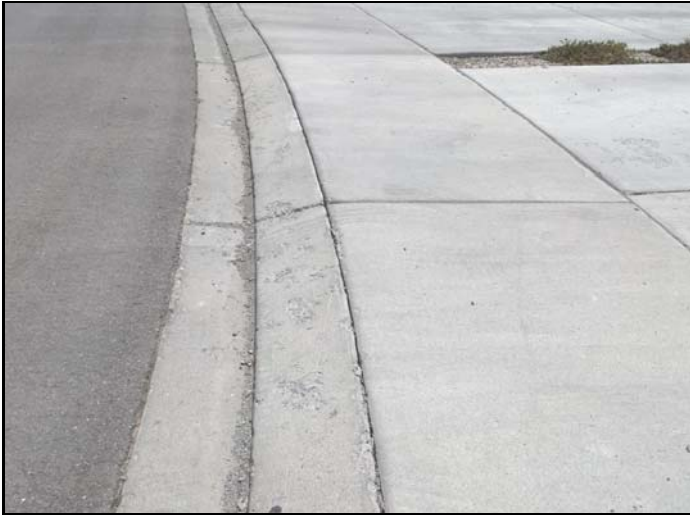
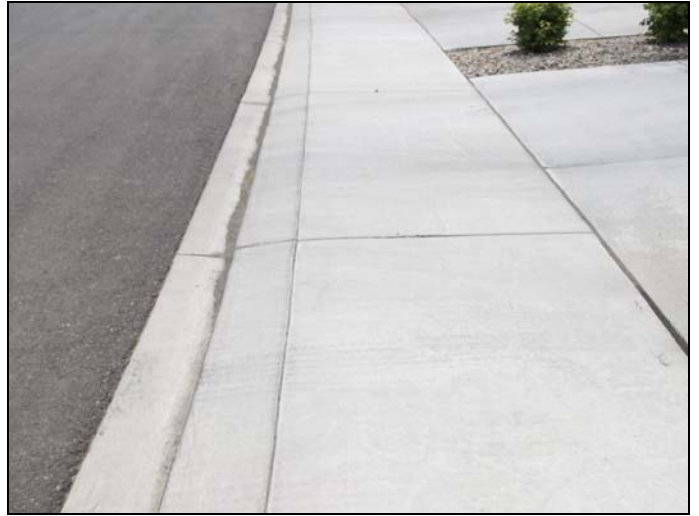
Comp #: 403 Concrete - Repair/Replace

The concrete is generally in good condition. Areas of cracking and spalling were noted at the time of the inspection. No expectation to completely replace the concrete surfaces. We recommend making local repairs as necessary as an operating expense and funding to make more significant repairs approximately every 10 years. Remaining life based on current age.

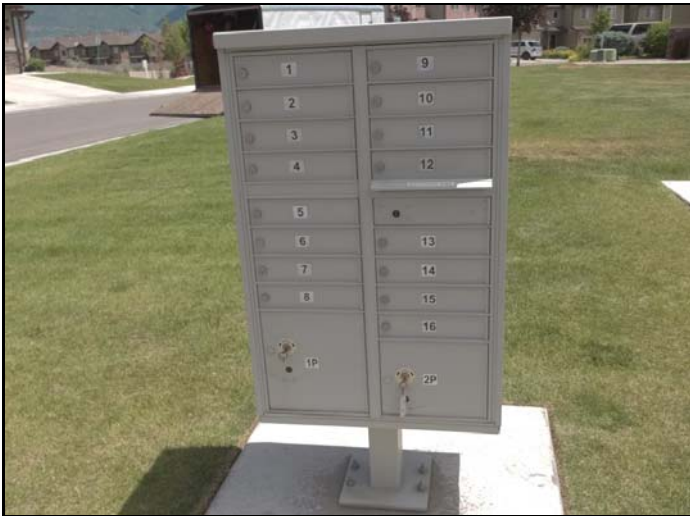
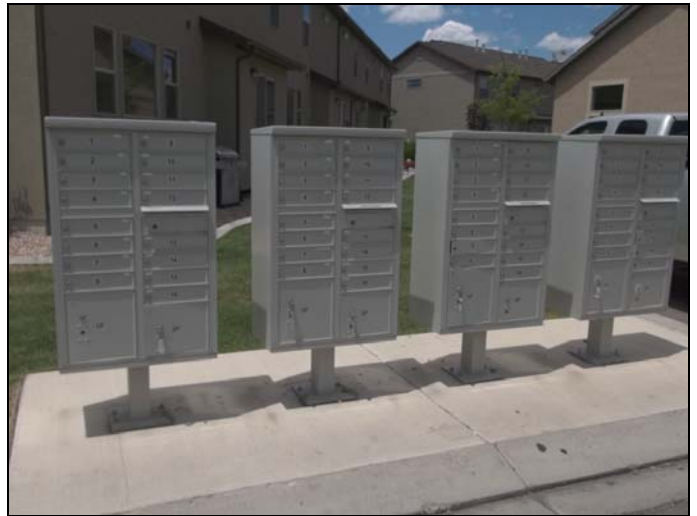
Comp #: 803 Mailboxes - Replace

The mailboxes are in good condition. Typically these mailboxes are owned and maintained by the postal service. No reserve funding necessary.

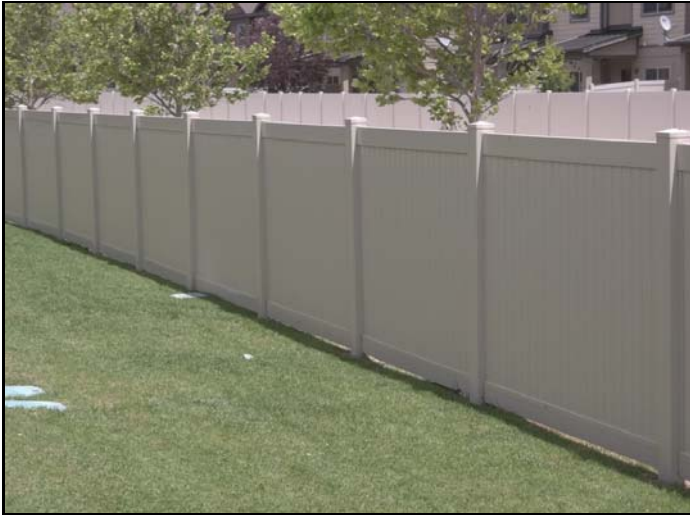
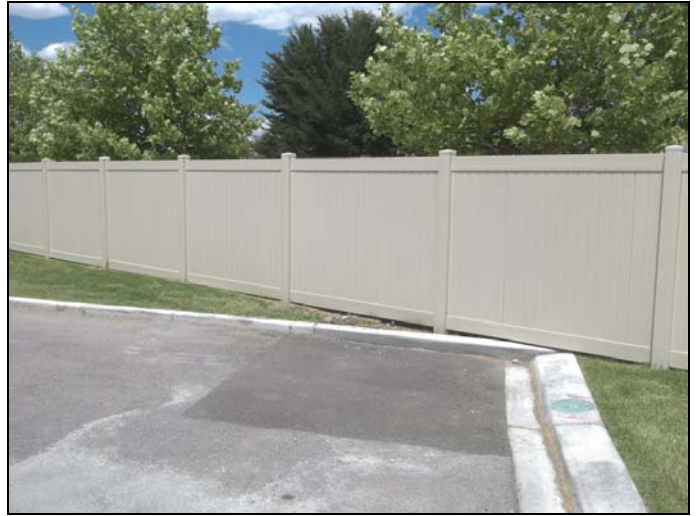
Comp #: 1008 Vinyl Fencing - Replace

The vinyl fencing is in good condition. We recommend funding to replace this component approximately every 25 - 30 years. Remaining life based on current age.

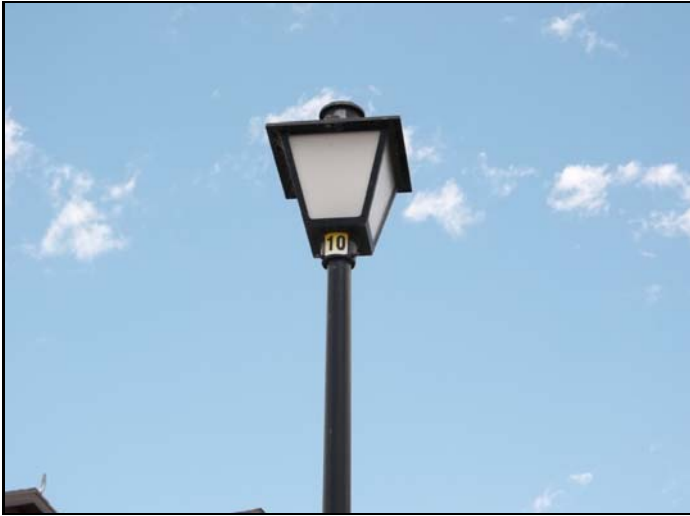
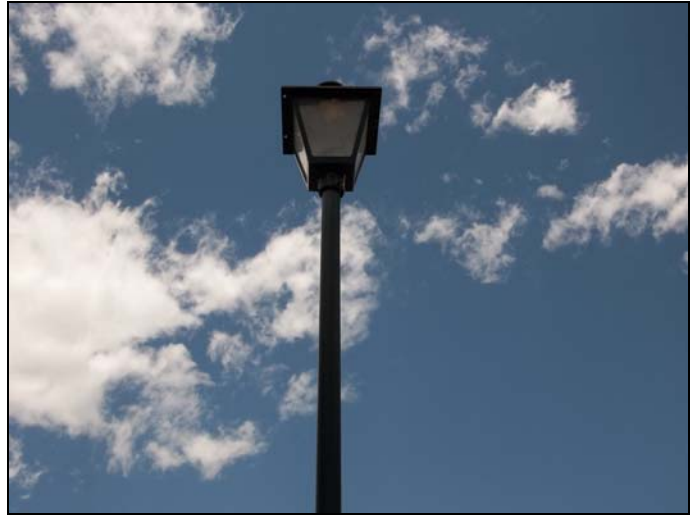
Comp #: 1609 Street Light Fixtures - Replace

The street light fixtures are in good condition. No expectation to replace the light poles. Paint poles as necessary as an operating expense. We recommend funding to replace this component approximately every 20 years to ensure proper function. Remaining life based on current age.

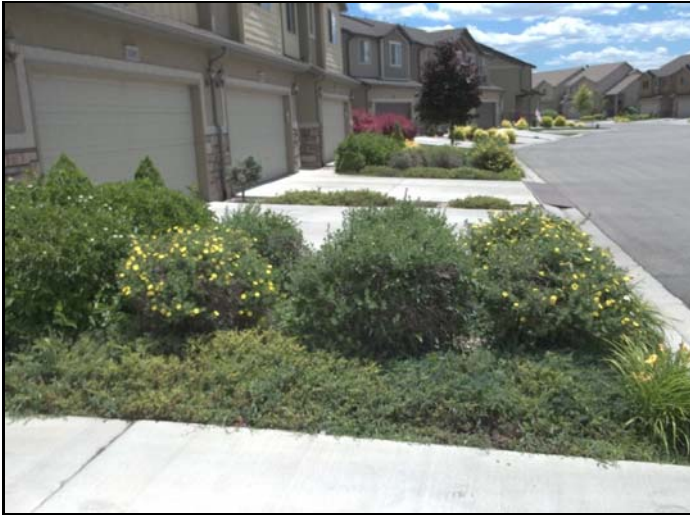
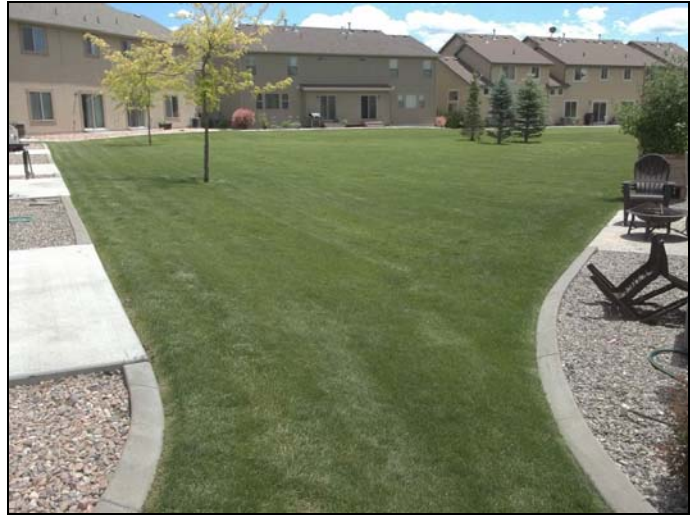
Comp #: 1812 Landscaping - Renovate

The landscaping is in good condition. No expectation to completely re-landscape the community. We recommend funding for an allowance to renovate the landscaping and irrigation system to maintain appearance and keep up with current decorative tastes. This component should be funded approximately every 20 years. Remaining life based on current age.
